**PRELIMINARY ASSESSMENT/
VISUAL SITE INSPECTION**

**AMERICAN TELEPHONE AND TELEGRAPH
COLUMBUS, OHIO
OHD 004 282 703**

FINAL REPORT

**U.S. ENVIRONMENTAL PROTECTION AGENCY
Office of Waste Programs Enforcement
Washington, DC 20460**

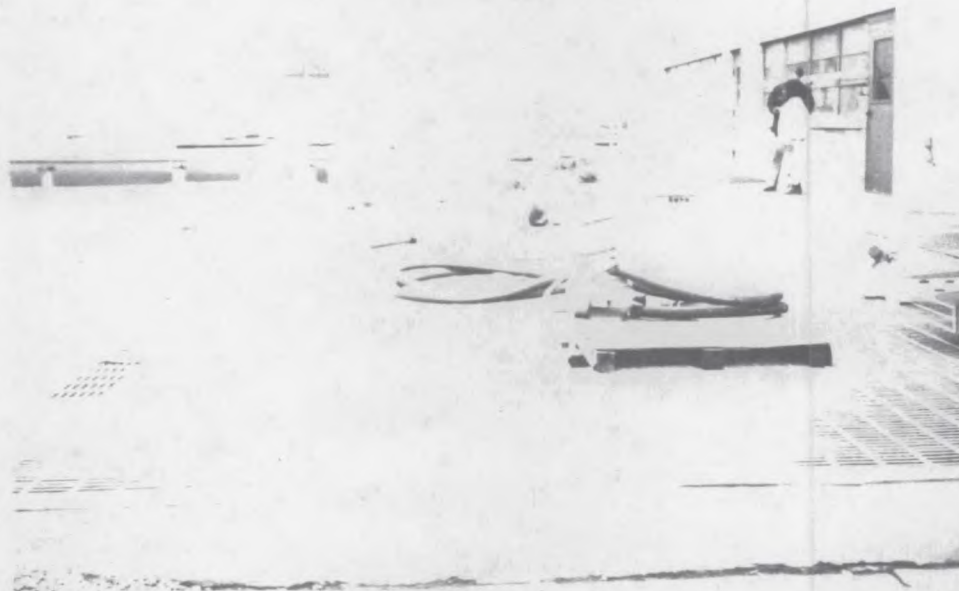
Photograph No. 1

PRC observed waste chromate, waste cyanide, and mixed acid and alkali wastes in the various outdoor tanks of this unit. PRC observed no cracks in the visible concrete. The indoor steel tanks appeared to be in sound condition. PRC observed no evidence of release (see Photographs No. 1, 2, and 3).

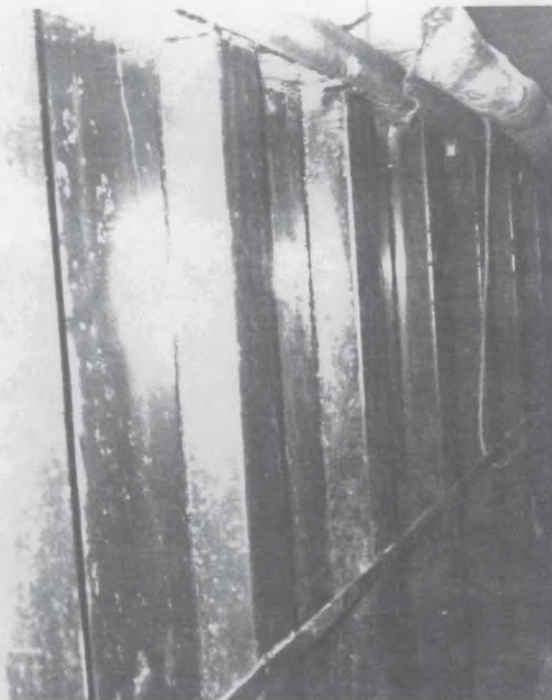
Photograph No. 5

Observations: The unit contained approximately 6 cubic yards of F006 wastewater treatment sludge. This steel unit appeared in sound condition. PRC observed no floor drains near this unit. PRC noted no evidence of release (see Photographs No. 5 and 6).

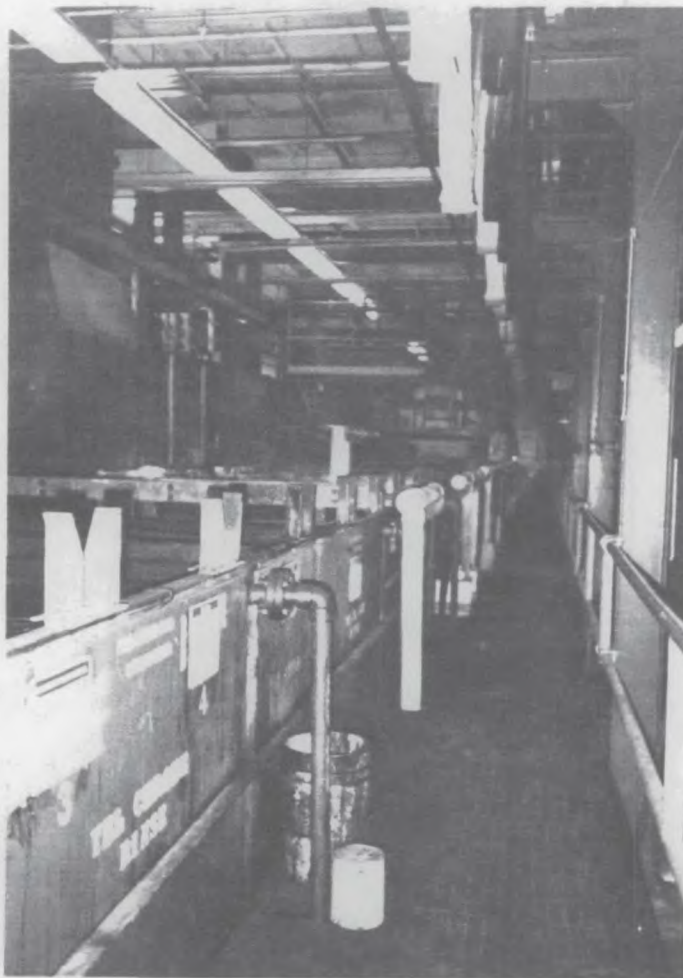
Photograph No. 7

Observations: The portion of this unit located below the programmable hoist plater and automatic nickel and chrome plater is covered by metal grating and was not visible. The portion of this unit below the acid-tin barrel plating tanks was partially visible during the VSI and contained metal pipes. However, the concrete surface of this unit could not be observed. PRC did hear one of the unit's pumps activate during the VSI (see Photographs No. 7, 8, and 9).

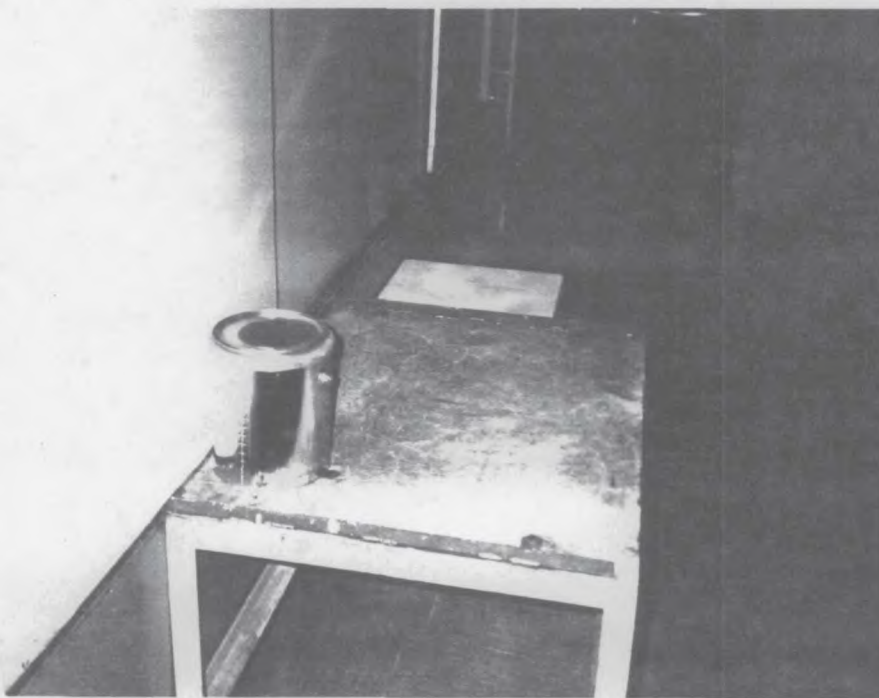
Photograph No. 13

Observations: During the VSI, the unit contained a partially filled 1-gallon bucket and a partially filled 55-gallon drum of waste solder dross. PRC noted no evidence of release (see Photographs No. 13 and 14).

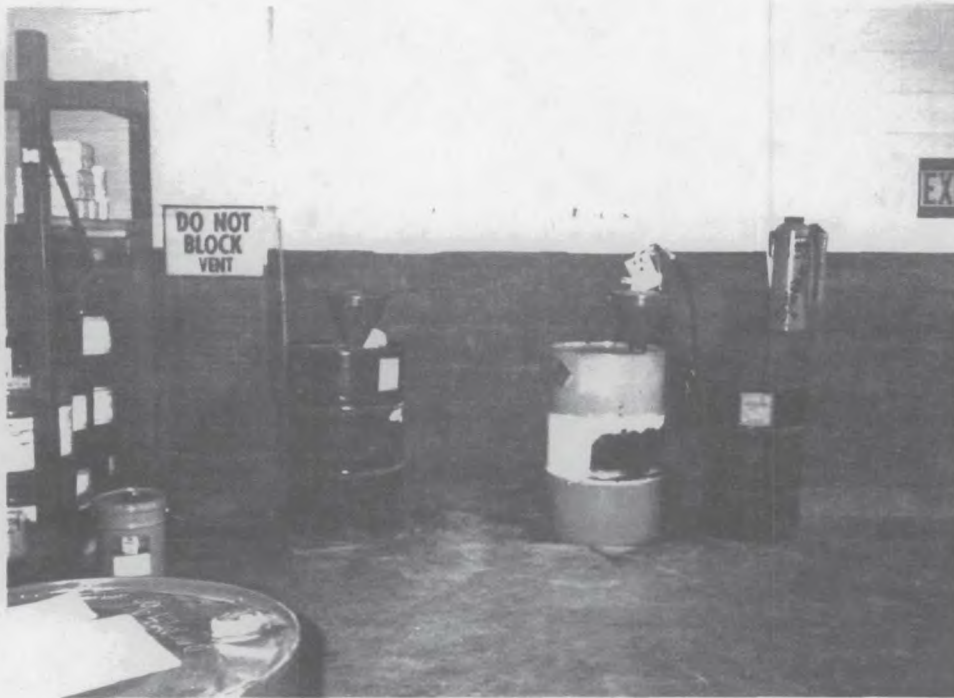
Photograph No. 18

Observations: The unit contained one partially filled 55-gallon drum of F003 and F005 wastes, and one partially filled 55-gallon drum of F002 nonflammable wastes. An empty 30-gallon drum was located adjacent to the 55-gallon drums. PRC observed staining on the concrete base of this unit. No cracks in the concrete were observed (see Photograph No. 18).

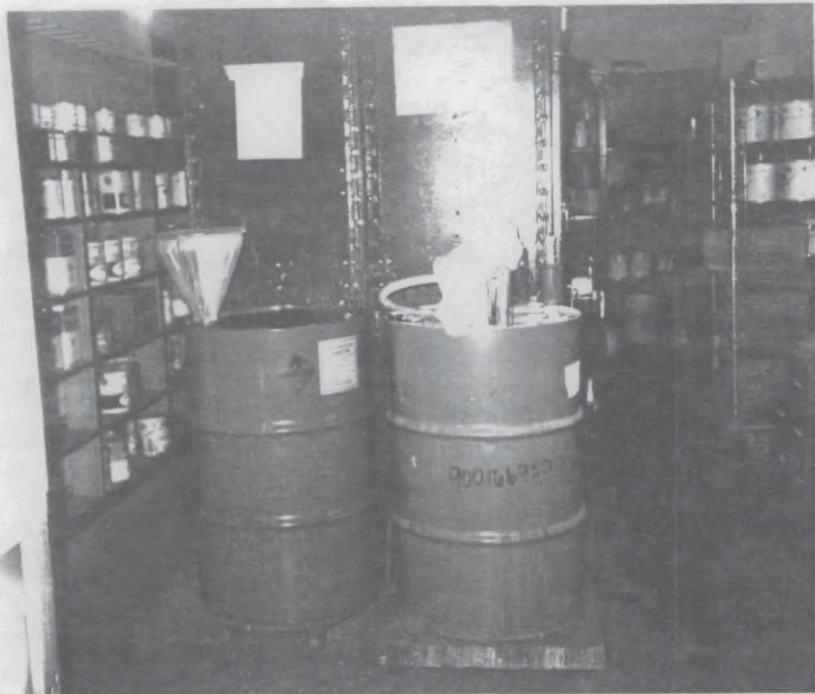
Photograph No. 24

The unit contained one partially filled 55-gallon drum of F005 waste paint. An adjacent 55-gallon drum contained detergent. PRC observed no evidence of release (see Photograph No. 24).
